SPECIAL EROSION CONTROL STUDY
SOUTH SHORE OF MOUTH OF MERRIMACK RIVER
VICINITY OF U.S. COAST GUARD STATION
PLUM ISLAND, MASSACHUSETTS

DEPARTMENT OF THE ARMY
NEW ENGLAND DIVISION, CORPS OF ENGINEERS
WALTHAM, MASSACHUSETTS 02154

JUNE 1969

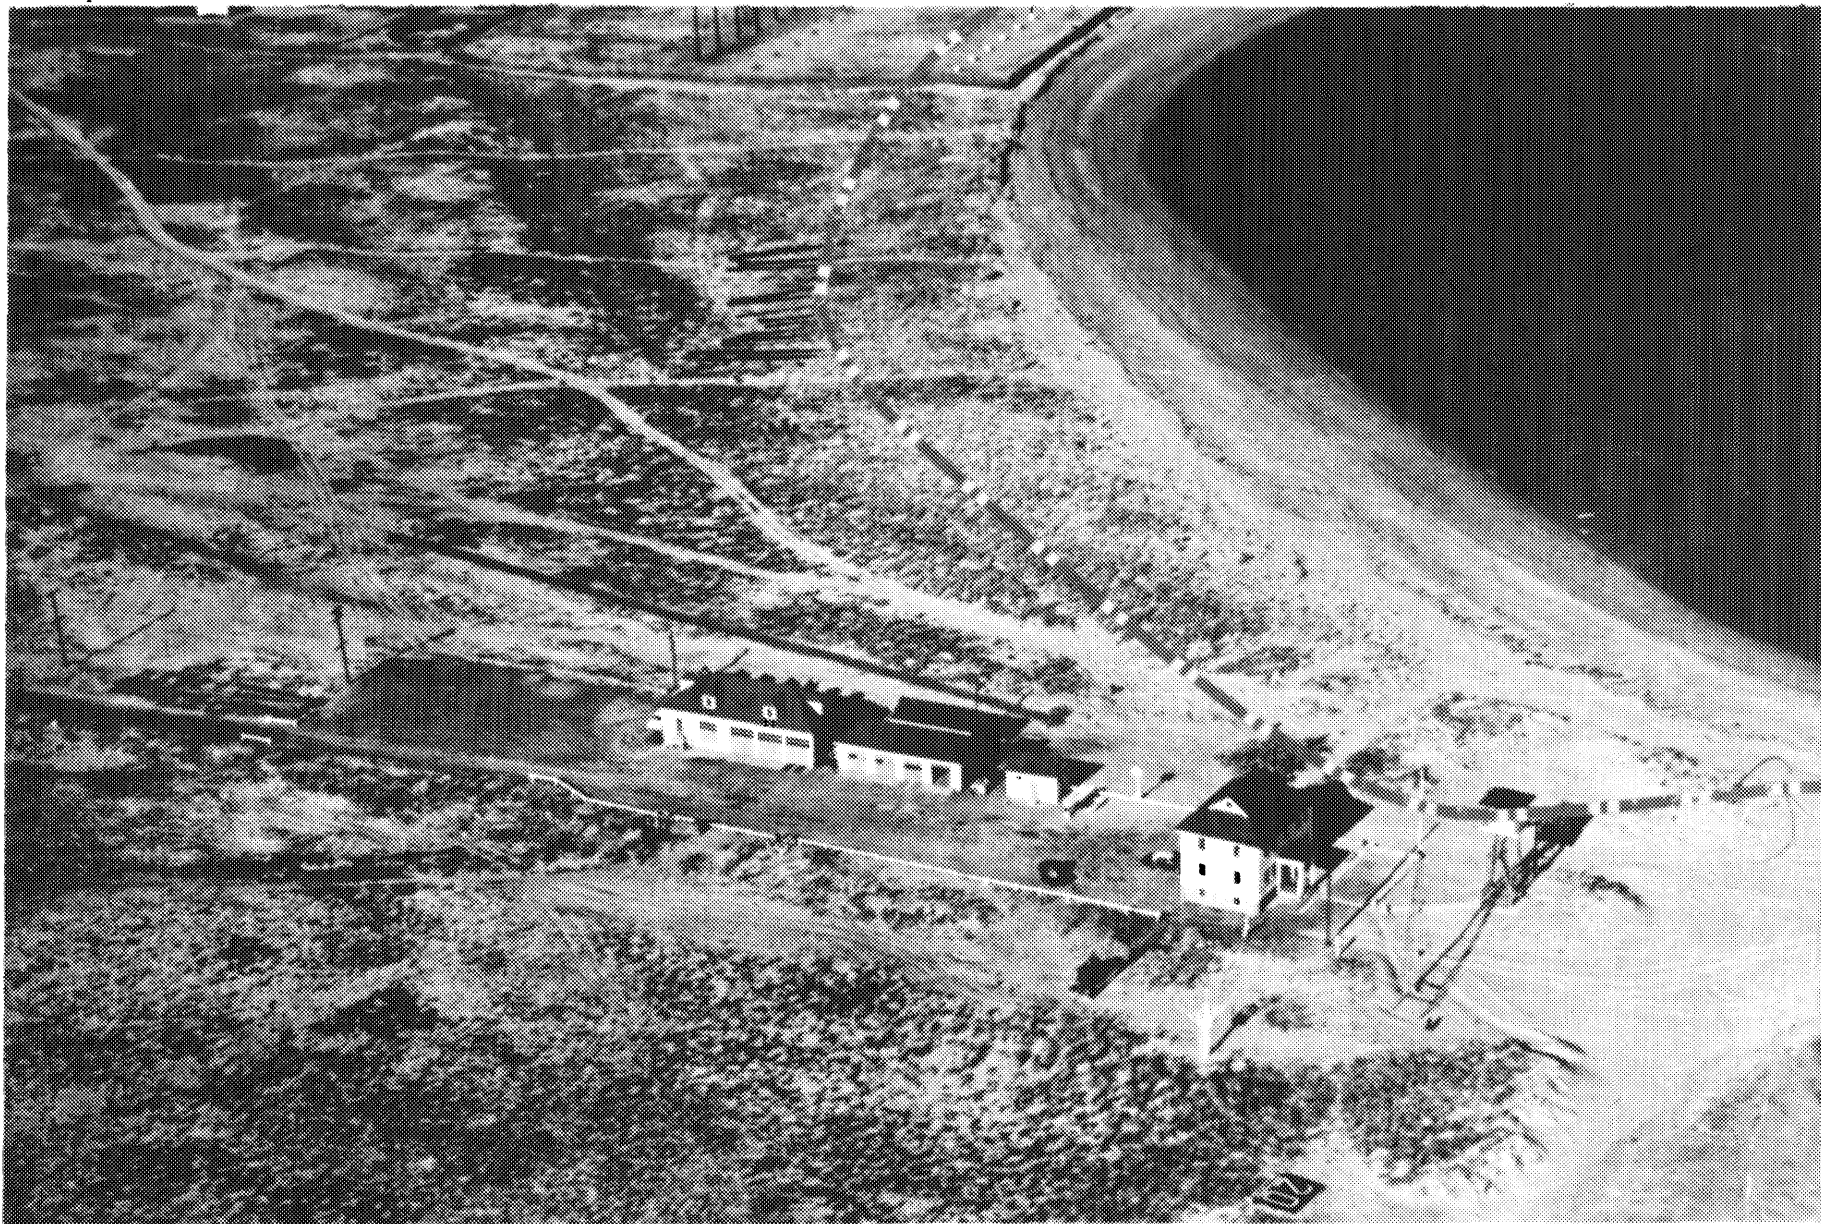
Photo 1. Looking northwest at United States Coast Guard Station, showing bank before erosion and approximate top of bank after erosion

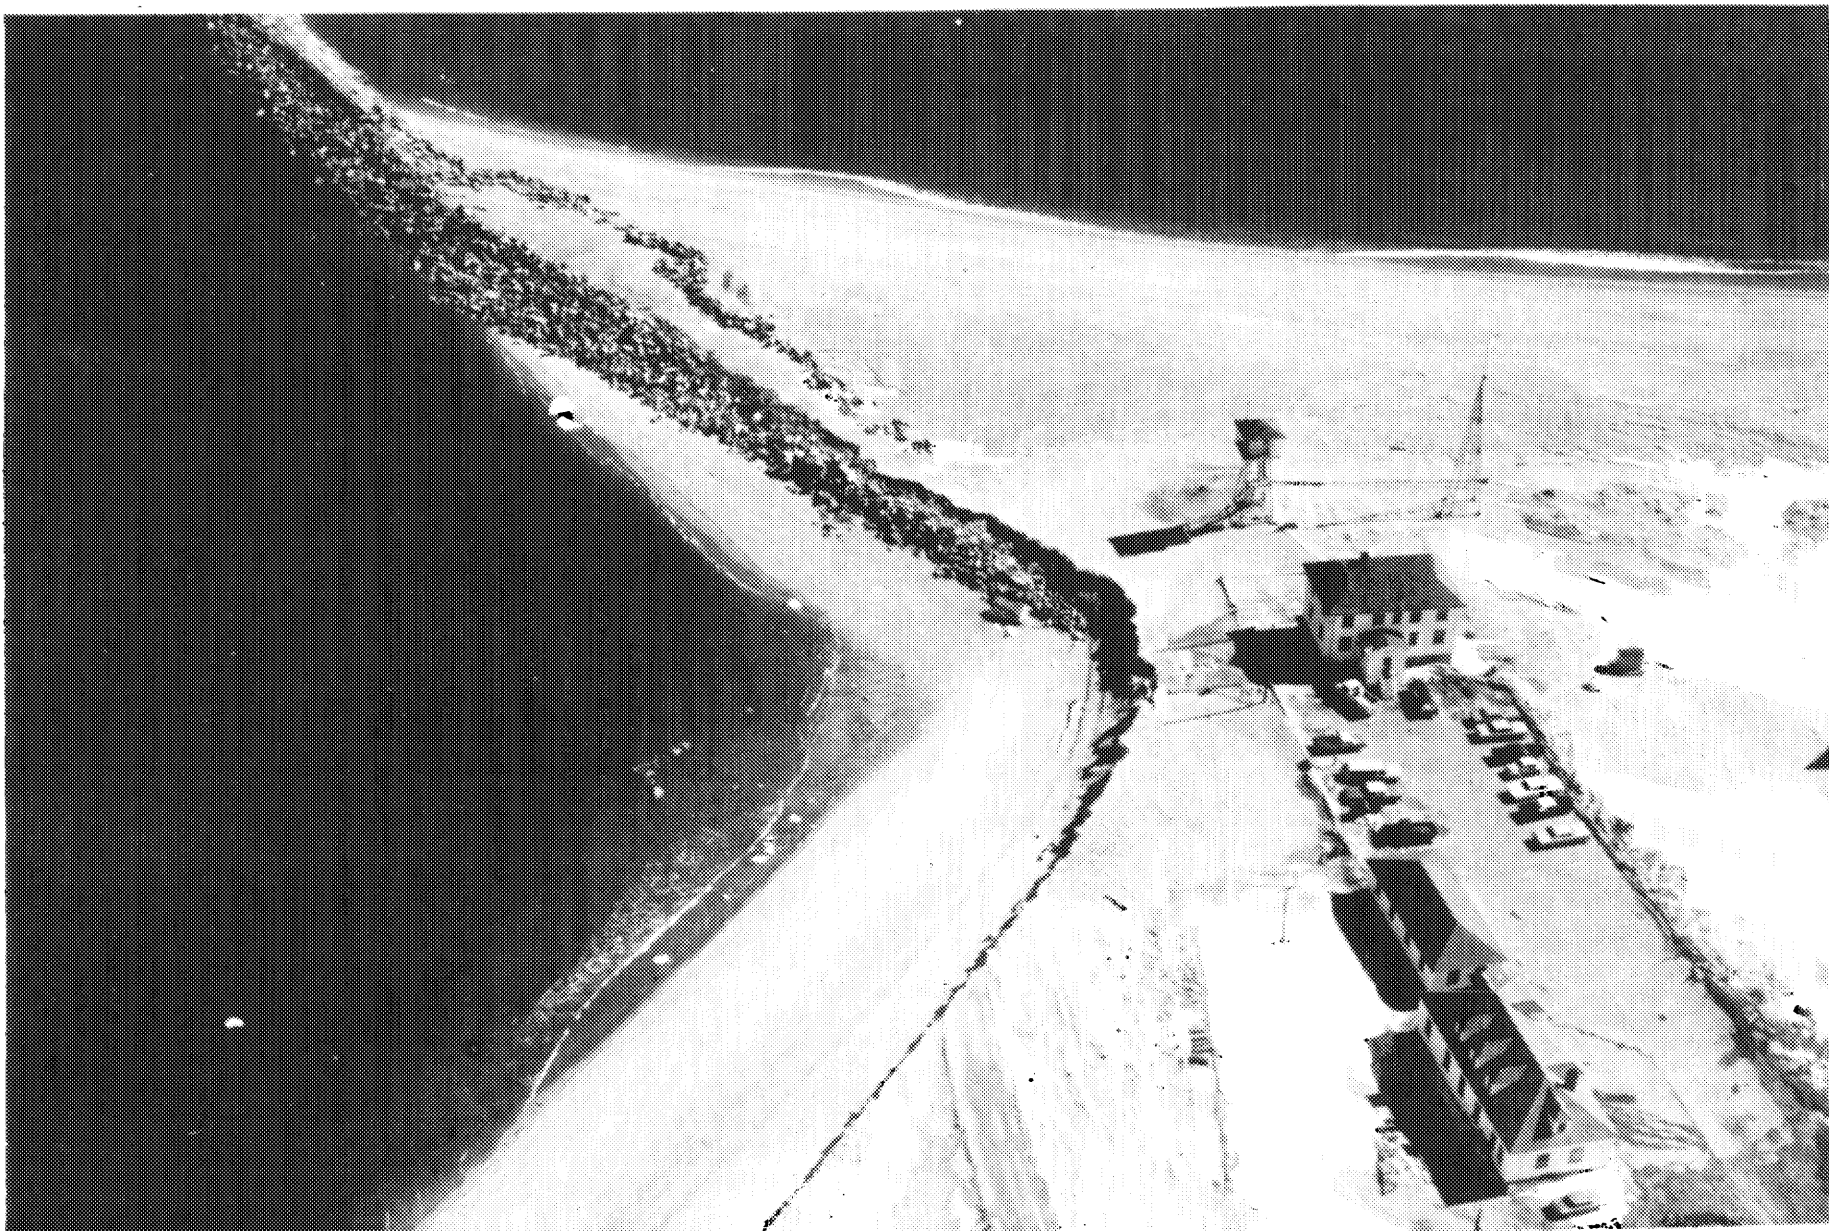
3. The Problem. The erosion along the south shore of the harbor entrance (see PHOTO 2) resulted from a series of three storms occurring between 9 and 27 February 1969. One storm lasted several days. A description of the storms is given in TABLE I. The storms occurred in a series, accompanied by strong northeast winds (40 to 50 miles per hour, fastest mile) with moderate wave action, and extended through a number of high tides (probably at least 18). The storms occurred during a period of neap or near neap tides. Otherwise, the storm-caused erosion could have been more severe. Based

4. Coast Guard personnel have stated that the large land losses experienced at the Coast Guard Station appeared to have been caused in part by the uncompleted jetty rehabilitation in progress at the time of the storms. They stated that their observations during the storms indicated alongshore currents at Plum Island, combined with the waves directed from the northeast, caused rapid loss of material. Field investigations indicate that the relative smoothness of the new jetty cross-section, combined with the relatively low-level opening resulting between the inner end of the uncompleted jetty and the dunes fronting the seaward shore of the station, very likely did play such a role. The opening acted as a spillway, probably increasing the velocity of runup, overtopping through it, thus causing flanking of the structure and expediting alongshore losses along the immediate river bank shorefront. PHOTO 2 shows the jetty construction and the opening at the inner end.

Photo 2. Looking east during intermediate tide along south jetty and top of dunes after erosion. Note location of dune line at Coast Guard Station and at opening inner end of jetty that is subjected to storm wave runup and overtopping.

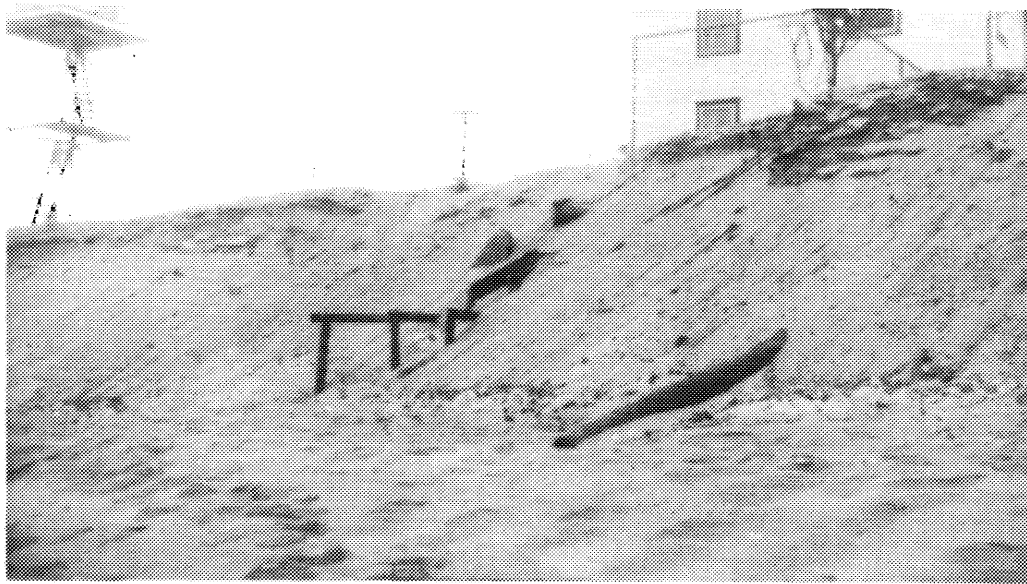
13. Runup. Because of the serious condition at the Coast Guard Station, with erosion leaving only about 45 feet of bank now fronting the river side of the Coast Guard barracks structure (see PHOTOS 2 and 3), runup studies have been made for the design condition for various slopes of rock-faced protection. It has been determined that, to eliminate wave overtopping at the exposed outer sector, revetment should have no slope flatter than 5 horizontal and 1 vertical. Also, level width of at least 70 feet at the existing elevation of the bank, but not less than 20.0 feet above mean low water, should be provided at the station proper.

Photo 3. April 1969 Coast Guard Station in the background. Top of bank is now 45 feet from station. Spring tide approaches base of slope. (Note: Since this photo, erosion has continued inland to undermine the fence)

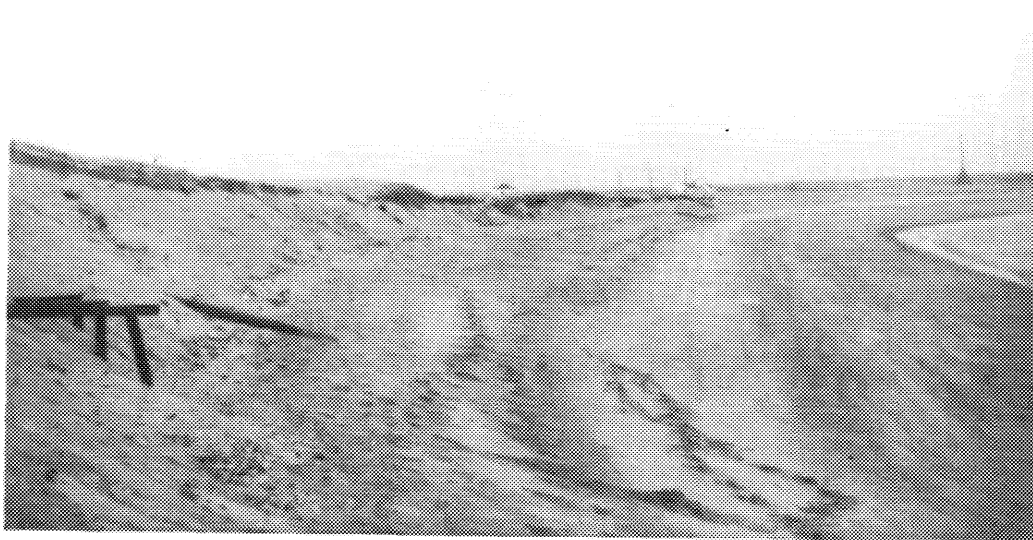
Photo 4. April 1969 Looking west along shoreline during low tide, along eroding bank vicinity of the Coast Guard Station.

Provide a protective improvement by extension of the present jetty construction landward with a top elevation at 19.0 feet above mean low water tying into the backshore, and construction of a sandfill rock-protected embankment along 400 feet of river front at the station, furnishing 70 feet of level width at a minimum elevation of 20 feet above mean low water fronting the barracks, thence sloping riverward on a slope of 5 horizontal on 1 vertical, and retained by a rock toe with a top elevation of 10.0 feet above mean low water. This structure would tie into the jetty and blend into a rock revetment which would continue westward an additional 200 feet. See PLATE 4 for the considered plan of improvement, and PHOTO 4 showing western extent of shore to be protected.
